# Manhole Inspection Summary

Manhole # S11Q\_\_004MH

Insp Date: **4/8/09 7:16 AM**

**Location** Address: **707 S.Caton Ave.**

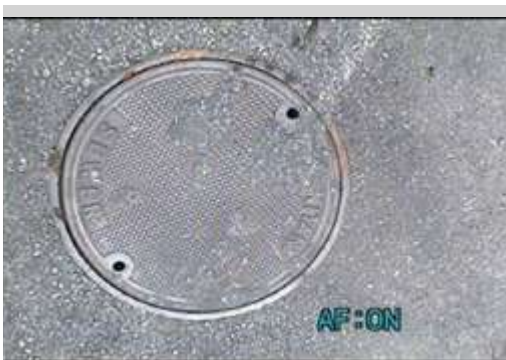
Misc.

cover view

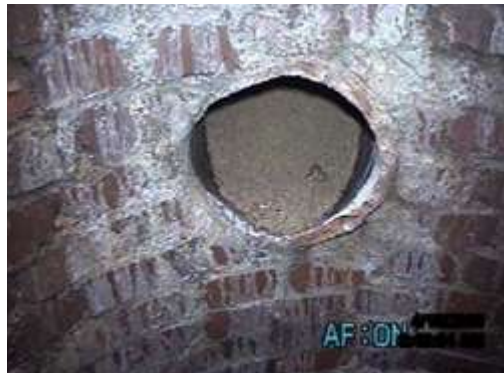
Misc.

Pipe In @ 12 is abandoned

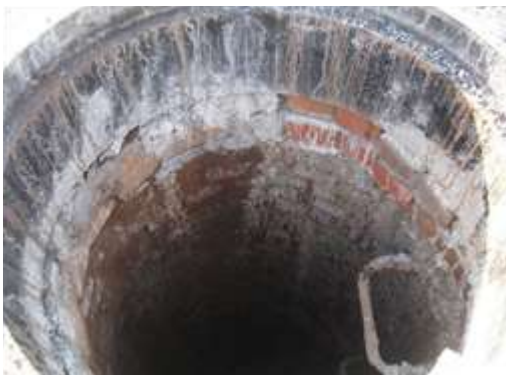
Defect 7

Infiltration: ☐ None ☐ Joint ☐ Cracks ☒ Mortar ☐ Roots ☐ Wall

chimney infiltration & missing mortar

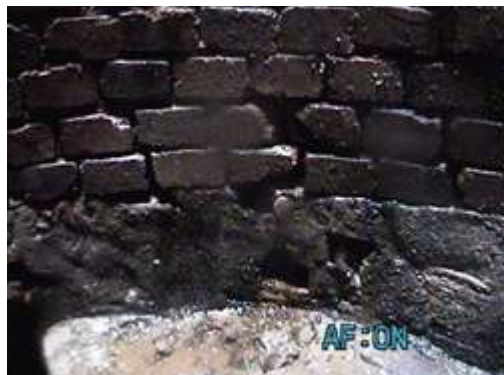
Defect 6

Condition: ☐ Sound ☐ Cracked ☐ Root Intrusion ☐ Loose Brick ☒ Deteriorated

Infiltration: ☐ None ☐ Joint ☐ Cracks ☐ Mortar ☐ Roots ☒ Wall

barrel wall infiltration & deterioration

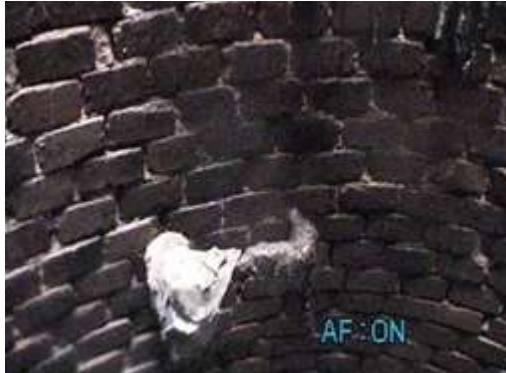
Defect 4

☒ Evidence Of Surcharge

Depth: **4**

evidence of surcharge on rung

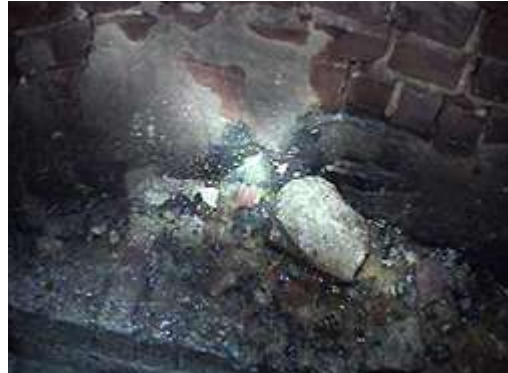
Defect 3

Condition: ☐ Sound ☐ Cracked ☐ Root Intrusion ☐ Deteriorated ☐ Leaks ☒ Debris

bench debris

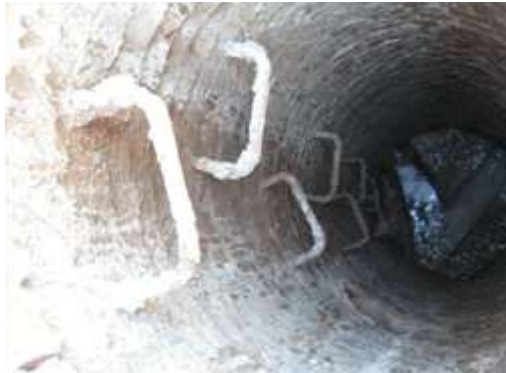
Defect 1

☒ Corroded

corroded rungs
